## HOW TO RESET A SMART CUSHION AFTER AN IMPACT FROM THE MANUFACTURER

# SMART CUSHION RESET

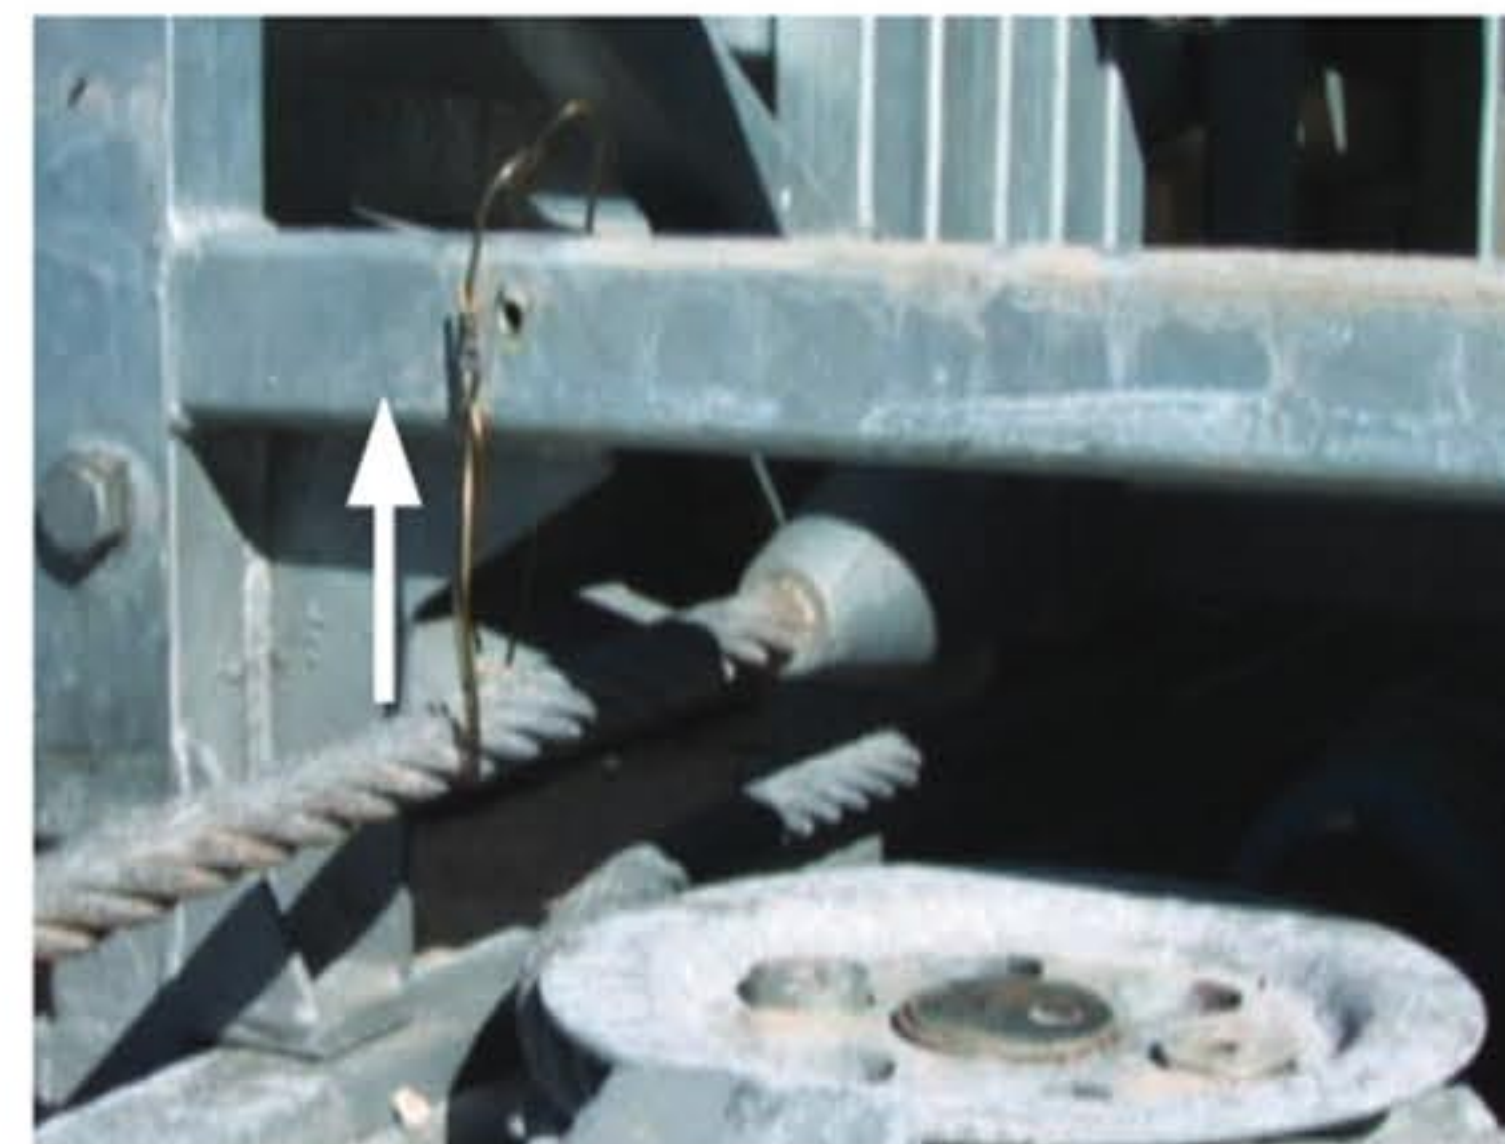
Fig. 1

1. Remove the front delineator panel and attach pulling means to the **bottom brace** of the front sled.
2. Use wire/bungee cord on the bottom brace at the front of the sled to hold the spelter socket up in the air while pulling out or it will catch on the base frame cross braces. (See Fig. 1)
3. Remove the front cable bracket that is located on the front sheave at the front of the attenuator. (See Fig. 2)
4. Attach a ½" Grade 100 chain to the bottom brace of the front sled.
5. Pull the sled forward one to two feet to give you slack on the cable.
6. If necessary, use the cable release tool to break cable loose from the sheave at the front of the attenuator if the zinc coating has attached the cable to the sheave. (See Fig. 3)

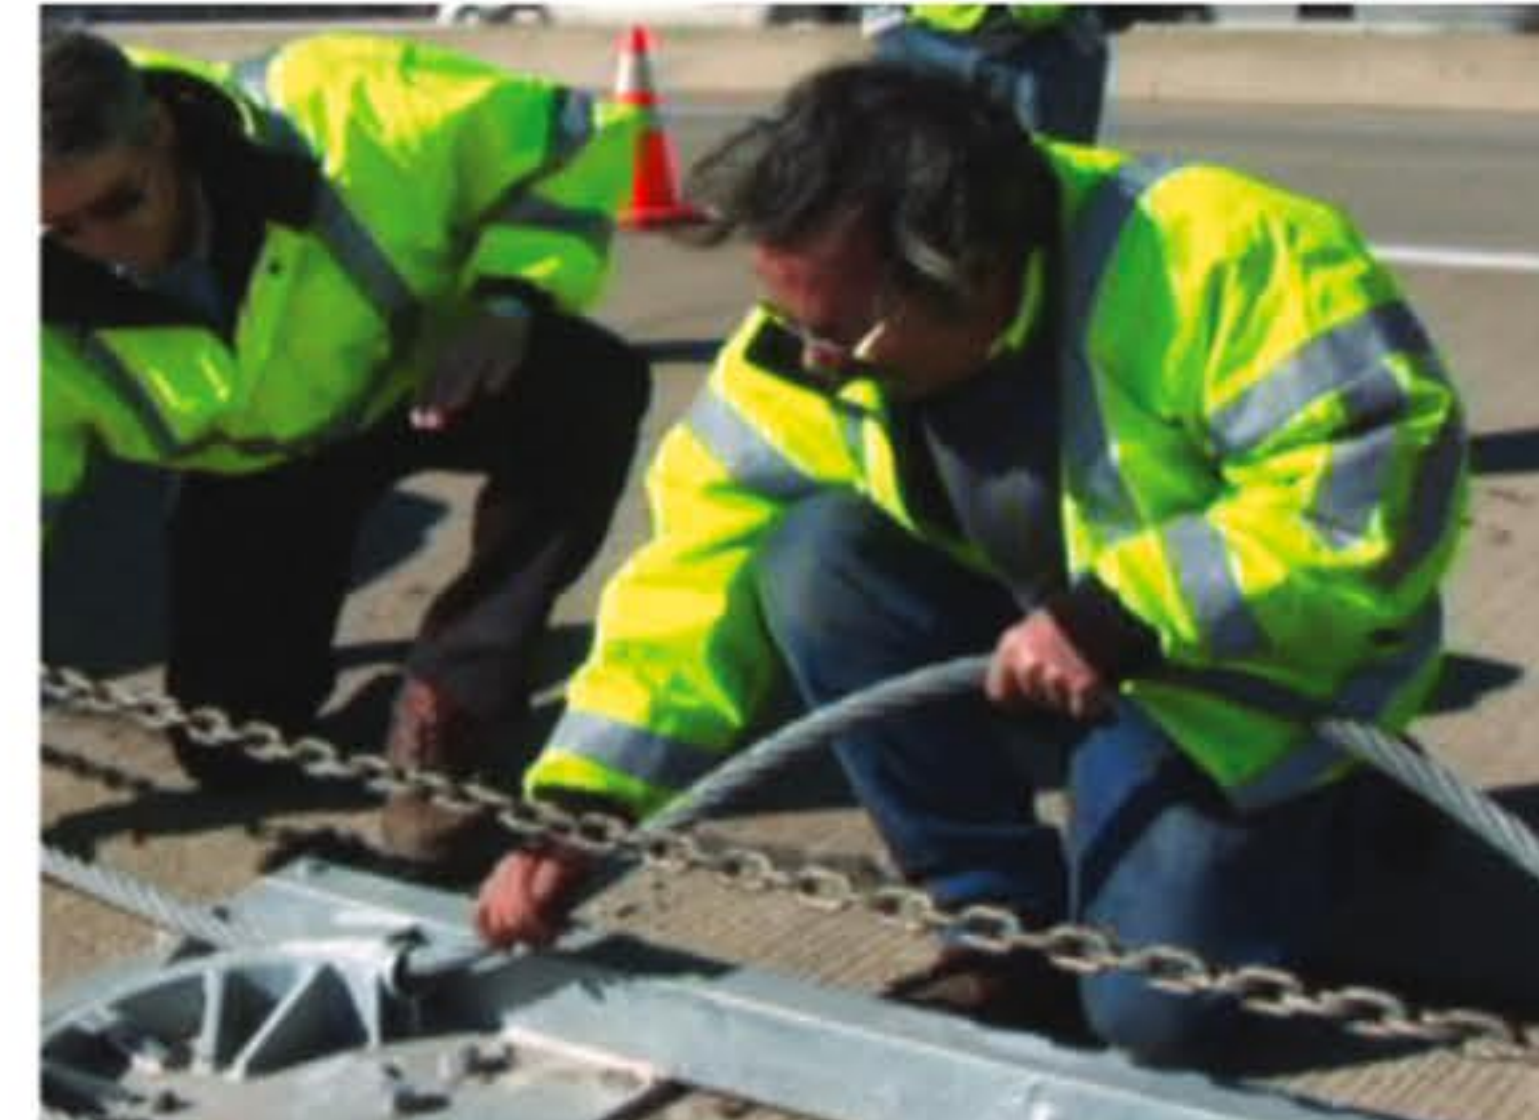
Fig. 4

7. Pull out in two foot increments while helping the cable feed out of the front of the unit. (See Fig. 4)

8. Pull the sled out the rest of the way in **short smooth increments** so you can help feed the cable out the front of the attenuator. This will give you a cable loop in front of the attenuator. **When you are past the last cross brace, you will need to remove the strap or wire to allow the cable to follow the path down into the front sheave.** The sled must be fully extended to replace the shear bolts. The sled should be no more than 1 inch from the stop bolts in the front.
